WELLINGTON - NAPOLEON WATERSHED STRUCTURE C-21
LAFAYETTE COUNTY, MISSOURI

MO 10284

PHASE 1 INSPECTION REPORT NATIONAL DAM SAFETY PROGRAM

PREPARED BY: HOSKINS-WESTERN-SONDEREGGER, INC.

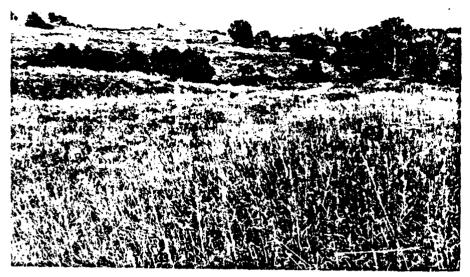
PHOTO NO. 2 LOCKING DOWNSTREAM IN EMERGENCY SPILLWAY

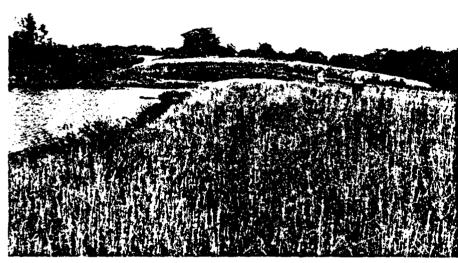
PHOTO NO. 5 UPSTREAM SLOPE FROM APPROXIMATE CENTER LINE

No significant erosion was noted on the upstream face of the dam. However, several rather large rodent holes were observed on the upstream slope.

(1) A program of regular inspection and maintenance should be initiated. The program should include measures to repair and control rodent holes and to control future tree growth (none observed at this time) on the embankment and to evaluate the progress and possible future affects of gully erosion near the outlet of the present emergency spillway. The grass on the embankment should be routinely mowed to enable early detection of rodent holes.
